WINTER SHELTERS FOR MARBLE SCULPTURES OF THE SCHLOSSBRÜCKE BERLIN: CLIMATIC CONSTRAINTS

Siegfried Siegesmund¹, Stephan Pirskawetz², Frank Weise², Rudolf Plagge³ and York Rieffel⁴

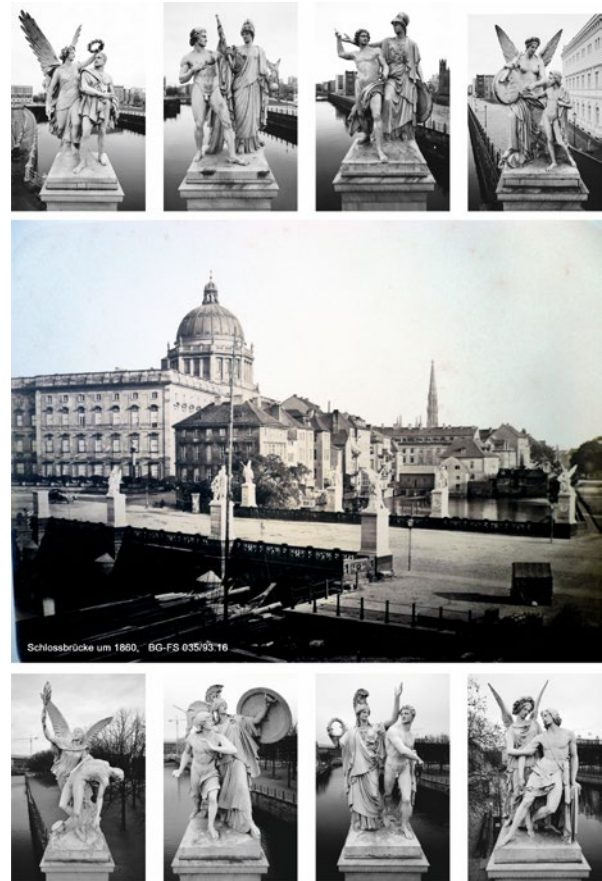
Figure 1: Small pictures: Current state of the sculptures. The photos are arranged in the same order as the sculptures in the historical photo. Historical photo of the “Schlossbrücke” before 1857. One sculpture (to the left) has not yet been assembled in this view.

In the beginning of the 20th century Berlin was one of the capitals that displayed the most public monuments in Europe. The “Schlossbrücke” with the sculpture ensemble was constructed between 1822 and 1824 in the classical style according to a design by Karl Friedrich Schinkel (Fig. 1). The theme of the eight sculptures is to create larger than life representations of ancient goddesses with young warriors. The Schlossbrücke ensemble of sculptures made from Carrara marble evokes the feeling of the Ponte Sant’Angelo Bridge in Rome. It can be considered an excellent example of the 19th century Berlin School of Sculpture, which attained a European wide reputation. When compared internationally, these figures belong to one of the most elaborate sculptural assemblies created from this period.

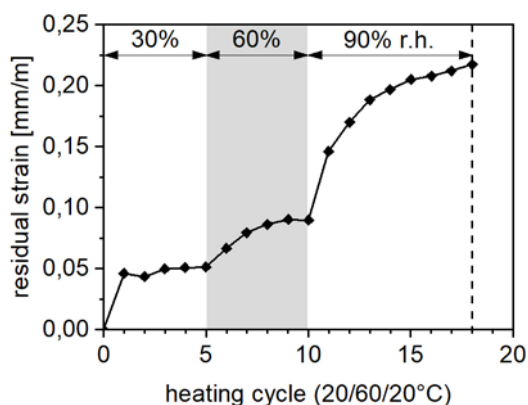
Figure 2: Residual strain of a marble comparable to the marble of the sculptures during thermal treatment under different moisture conditions.

the project, a Carrara marble was treated thermally at four cycles (20 °C – 60 °C – 20 °C) under dry conditions, followed by five heating cycles at 60% relative humidity and 90% relative humidity for the next eight cycles. The measured residual strain (Fig. 2) indicates that a progressive deterioration also occurs at high air humidity without the presence of liquid water.

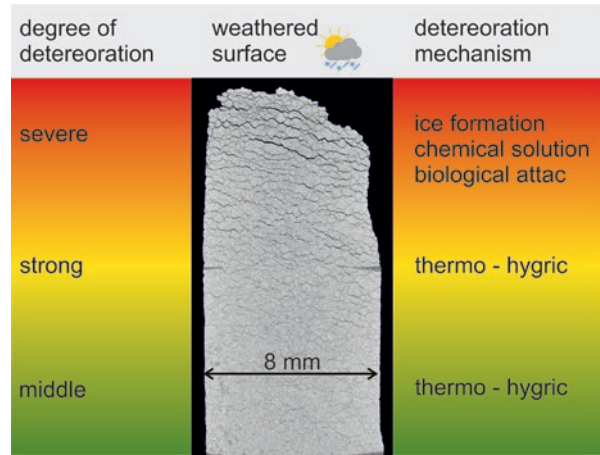
Figure 4: The x-ray ct- image of a drilling core shows a pronounced damage profile with a distinct cracking near the surface. The condition of the material is related to the depth and to the assumed deterioration mechanism.

A drilling core was taken from a vertically oriented surface of the sculpture on the south-east side of the bridge. The x-ray computed tomography (Fig. 4) clearly shows a distinct damage profile. Near the surface strong microcrack deterioration parallel to the surface can be observed.

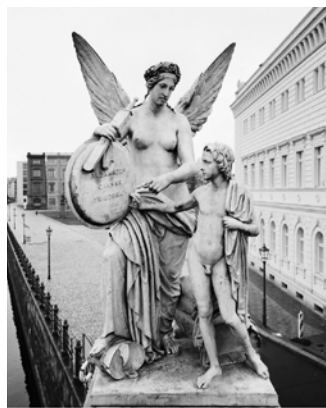
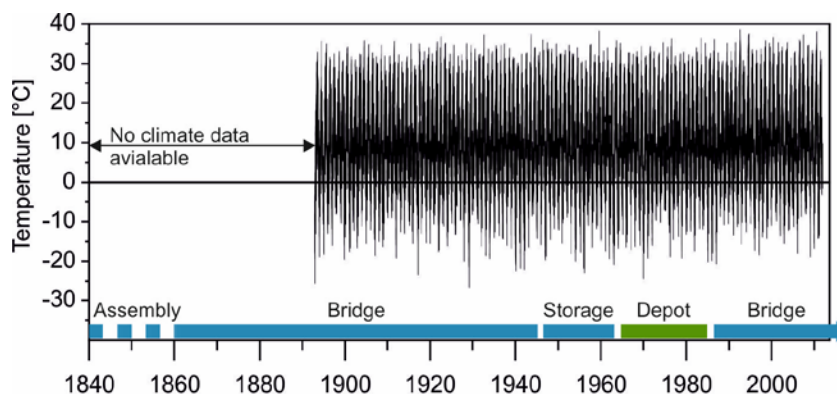
Figure 5: Daily maximum and minimum air temperature in Potsdam (data based on (DWD 2012)) compared to the exposition history of the sculptures at the Schlossbrücke in Berlin.

The current state of preservation of the marble sculptures is a result of their long term exposure to the climate. Figure 5 illustrates the weathering history of the Schlossbrücke. The present data originates from a meteorological station in Potsdam, located about 30 km south-west of the Schlossbrücke. Since 1893, air temperatures range from $-25\text{ }^{\circ}\text{C}$ in the winter up to $40\text{ }^{\circ}\text{C}$ in the summer. This represents a temperature span of about $65\text{ }^{\circ}\text{C}$. During their exposure on the bridge, the sculptures may experience about 140 air temperature fluctuations ranging from $-15\text{ }^{\circ}\text{C}$ to $30\text{ }^{\circ}\text{C}$. Even under dry conditions these temperature fluctuations led to a deterioration that also affects voluminous parts of the sculptures. Besides these long term fluctuations, the daily temperature changes also play an important role. Since 1893, on more than 4500 days the difference between the temperature maximum and minimum is greater than 15K, and on more than 20,000 days it exceeds 10K. In combination with the air humidity, that typically ranges from 50% to 95% in summer and 75% and 95% in winter, these high number of temperature fluctuations is responsible for the high degree of deterioration in the near surface zone. Due to the partially increased porosity, the surface is locally sensitive to freeze-thaw action. The climate data from Potsdam show that during the last 120 years on more than 700 days the temperature decreased from $+1\text{ }^{\circ}\text{C}$ to $-5\text{ }^{\circ}\text{C}$ and on about 1600 days the maximum temperature was below $-3\text{ }^{\circ}\text{C}$. Therefore,
